IRENE B. FRENCH COMMUNITY CENTER

Volume 2- Assessment and Feasibility Study Treatment Recommendations and Use

City of Merriam, Kansas Parks and Recreation
5701 Merriam Drive
Merriam, Kansas 66203

95% Draft Report
VOLUME 2
May 5, 2015

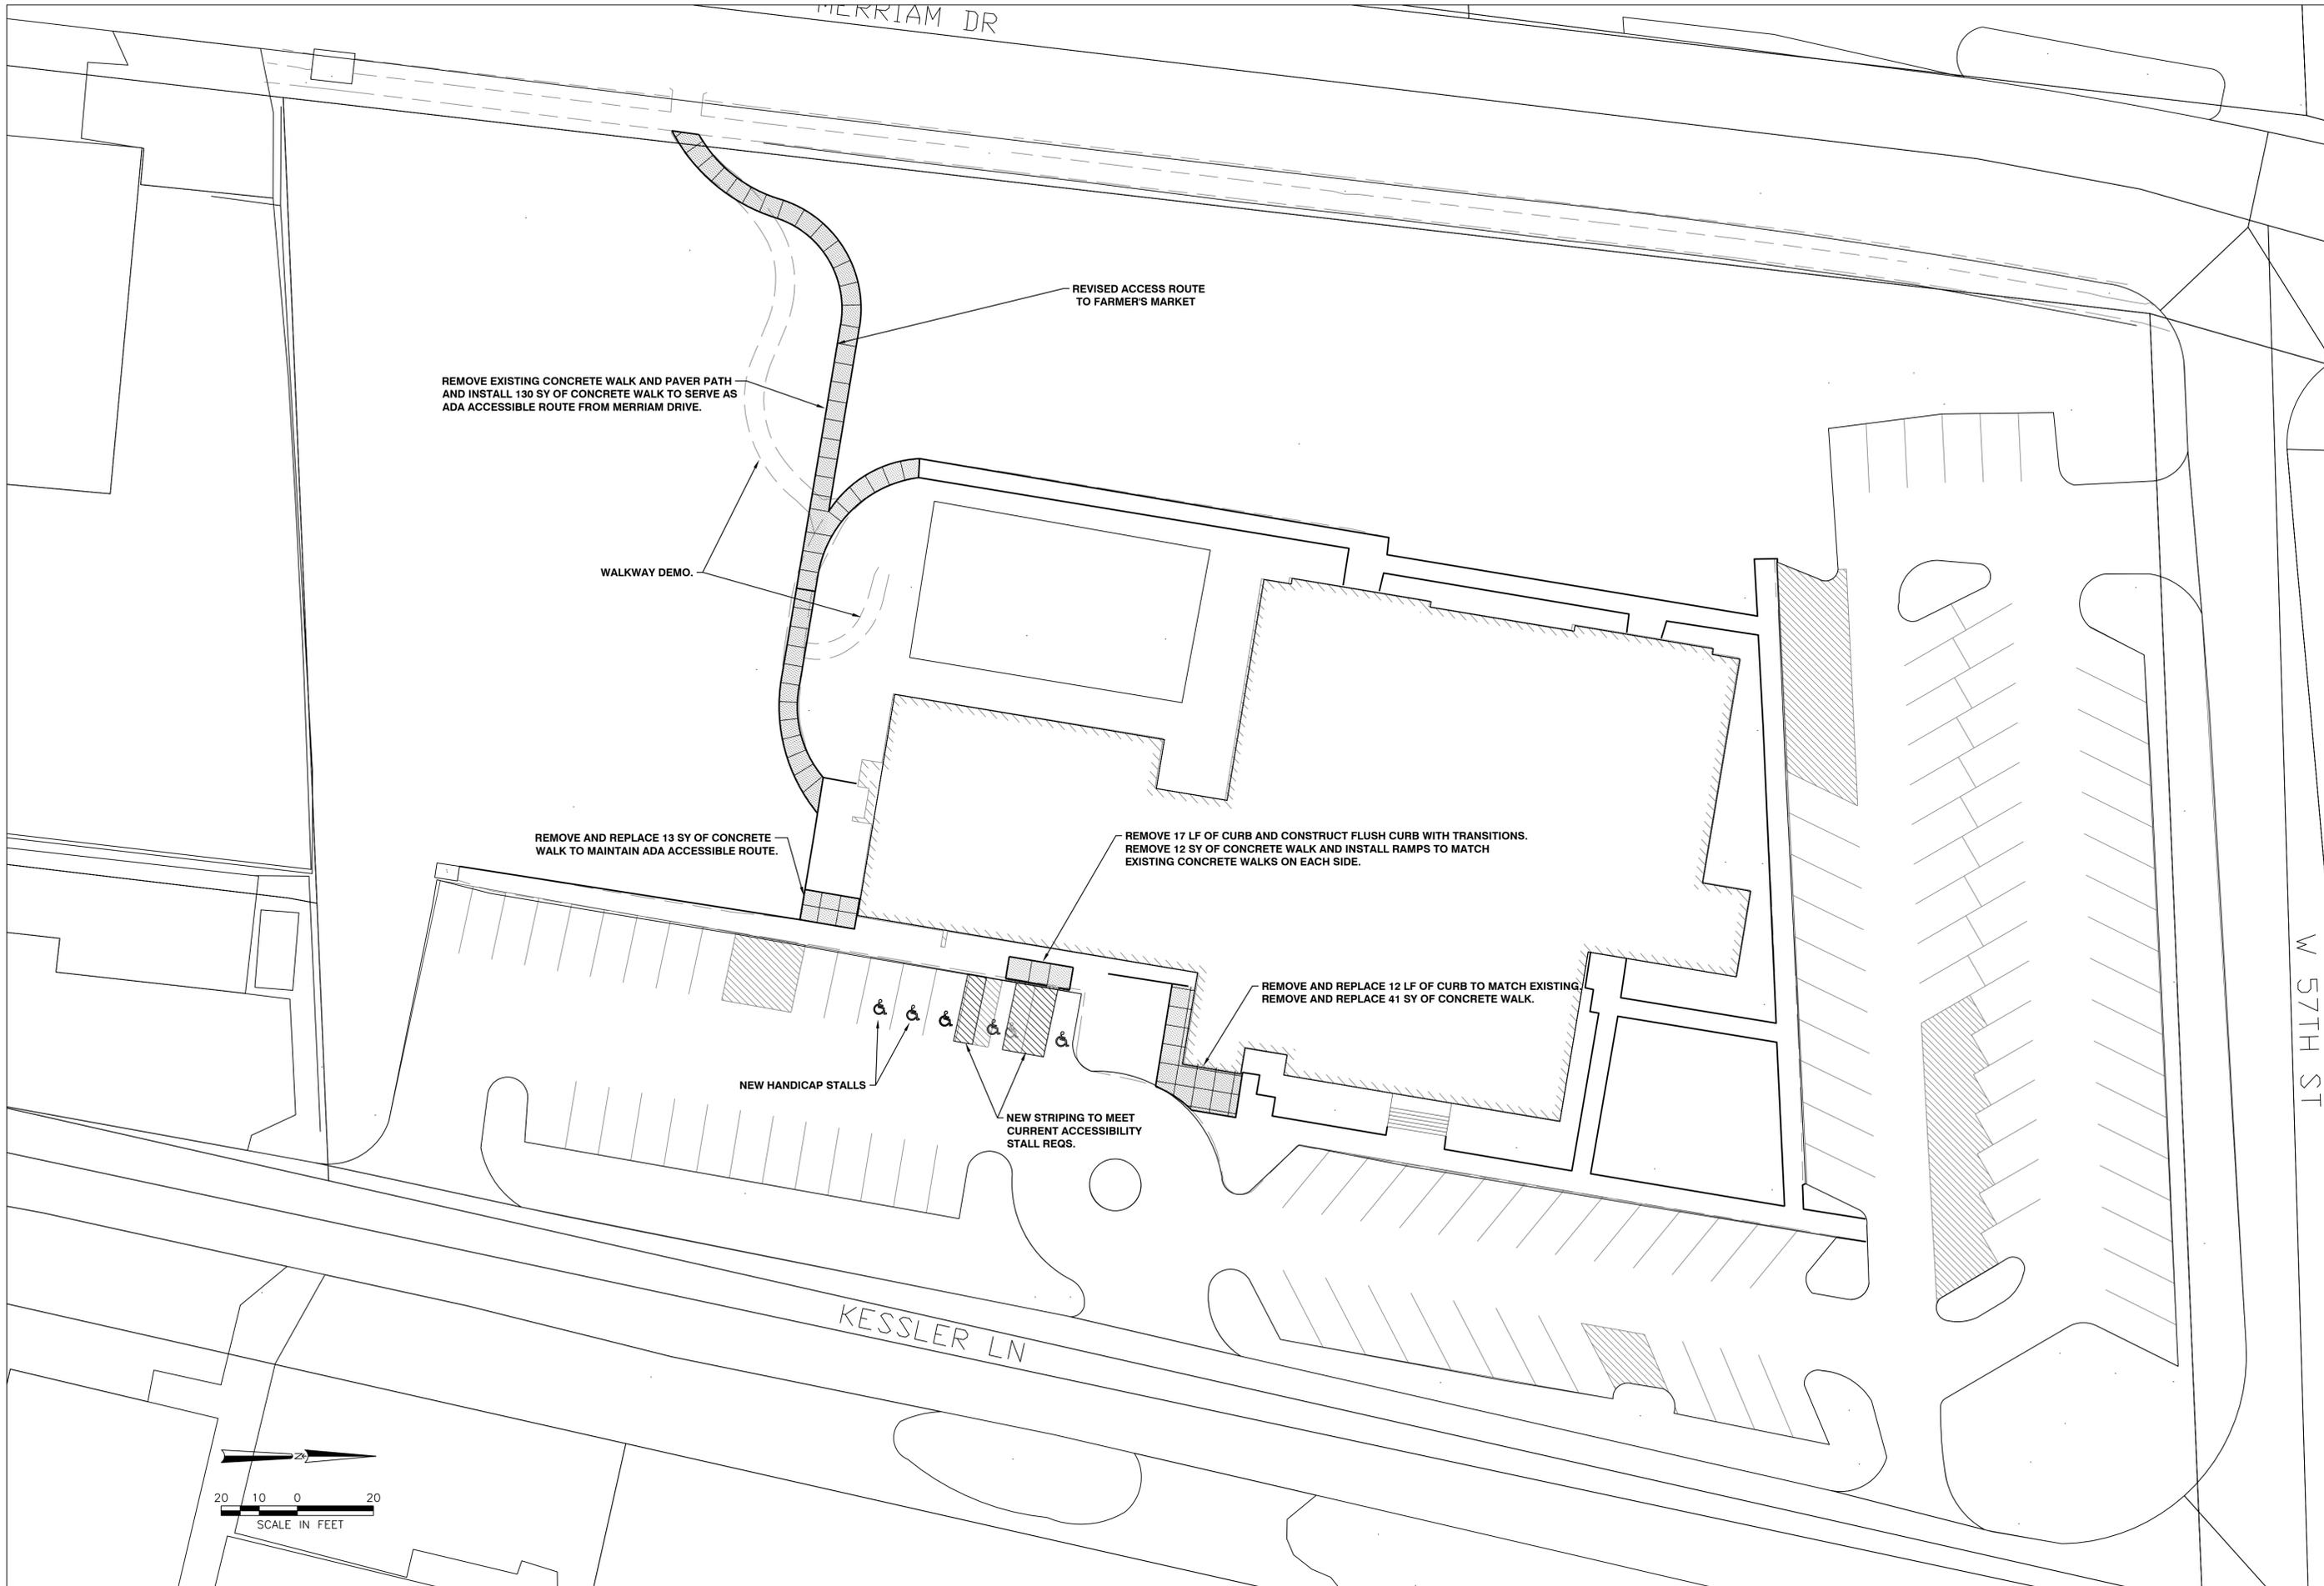
At the request of the Merriam Community Director, Anna Slocum, SK Design Group (SKD) included an analysis of an accessibility route from Merriam Drive to the Irene B. French Community Center in order to gain an ADA accessible route for pedestrians to use during Farmer's Market events. The idea being that the increased activity can be utilized to coordinate Merriam Community Center events simultaneously. It was found that the existing concrete walk from Merriam Drive exceeded the maximum allowable grade to be considered an ADA accessible route. Moreover, portions of the concrete paver path have a cross slope that exceeds the maximum allowable slope of 2.0%. Therefore, a proposed accessible route was designed as depicted in Exhibit 3.

REMOVE EXISTING CONCRETE WALK AND PAVER PATH AND INSTALL 130 SY OF CONCRETE WALK TO SERVE AS ADA ACCESSIBLE ROUTE FROM MERRIAM DRIVE.

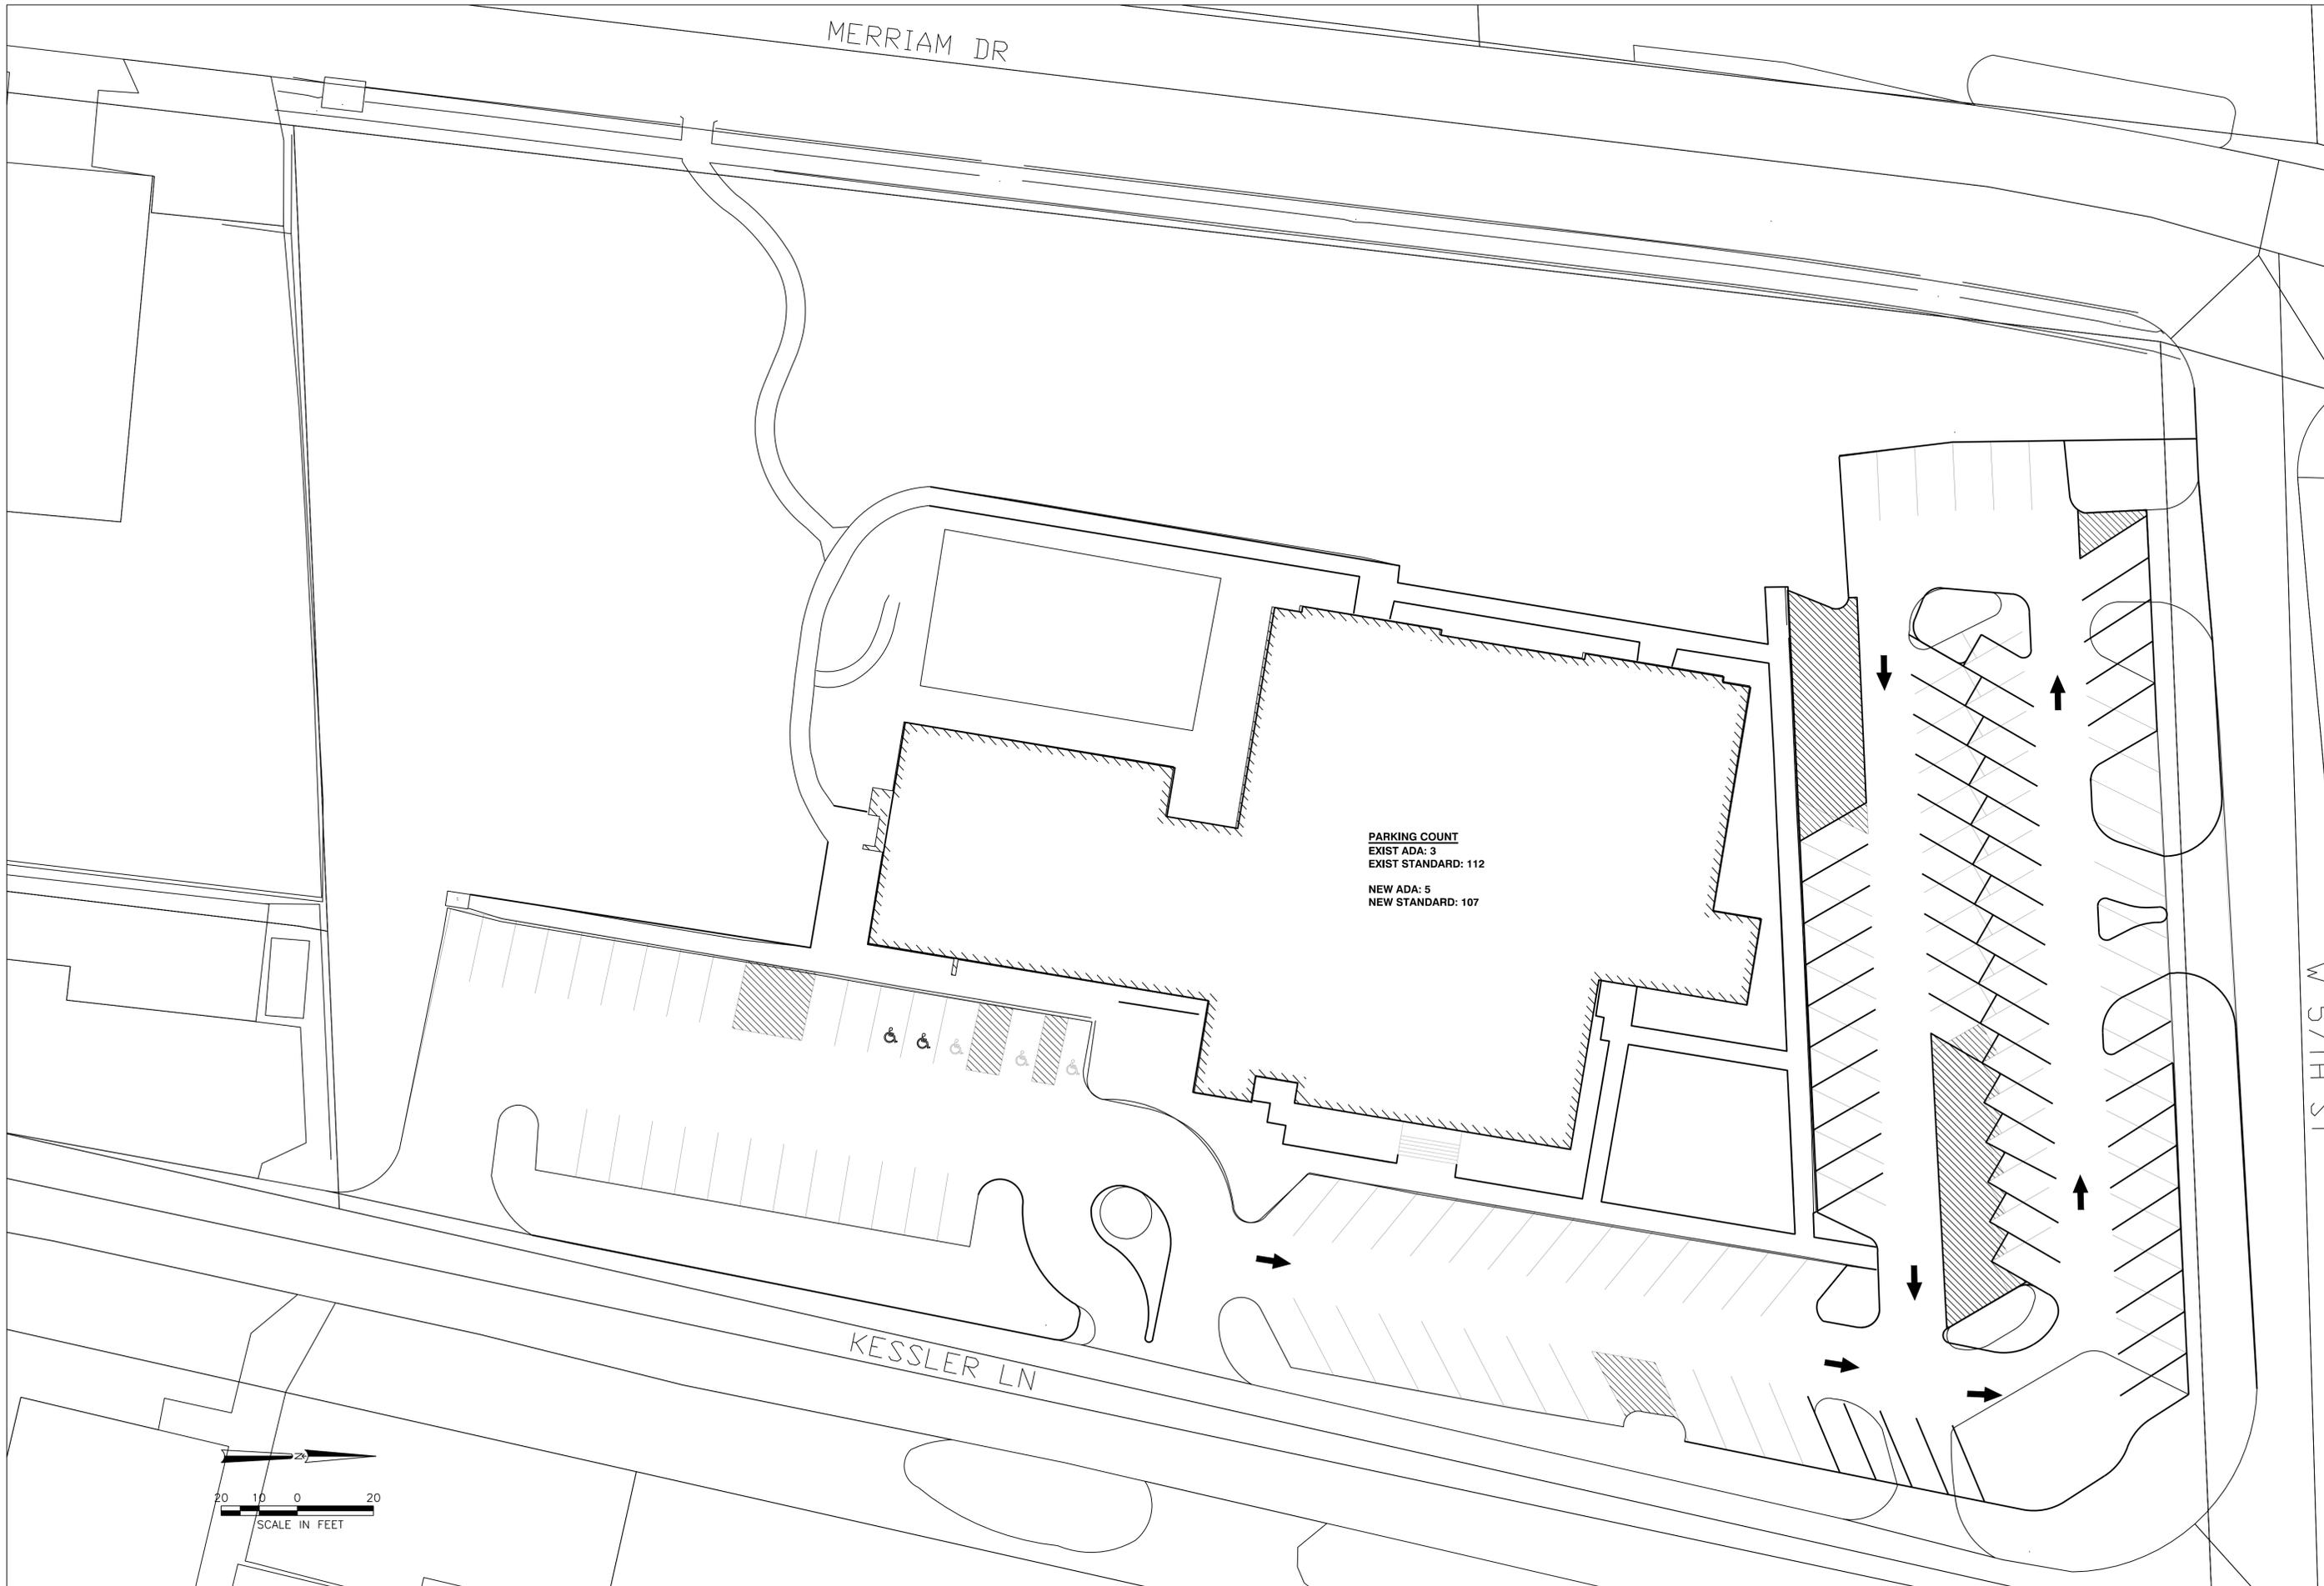
PARKING CIRCULATION
OPTION 1
EXHIBIT 4

During the assessment, it was observed that patrons were driving through the north parking lot, travelling the wrong direction down one-way lanes of travel on several occasions. The north parking appears to be designed to maximize parking, although the current layout is confusing to patrons. Two options for redesign of the northern parking lot were generated in order to promote a natural flow of traffic from the entry, in and around the northern parking lot. Option 1 (Exhibit 4) is the least intrusive with the majority of the work consisting of restriping the parking stalls and the reconfiguration of the two existing islands, effectively reversing the direction of travel. Option 2 (Exhibit 5) is more intrusive which includes the work as a part of Option 1, as well as relocation of the entry/exit from 57th Street and closure of the one-way exit from Kessler Lane. Both options result in a reduced number of parking stalls.

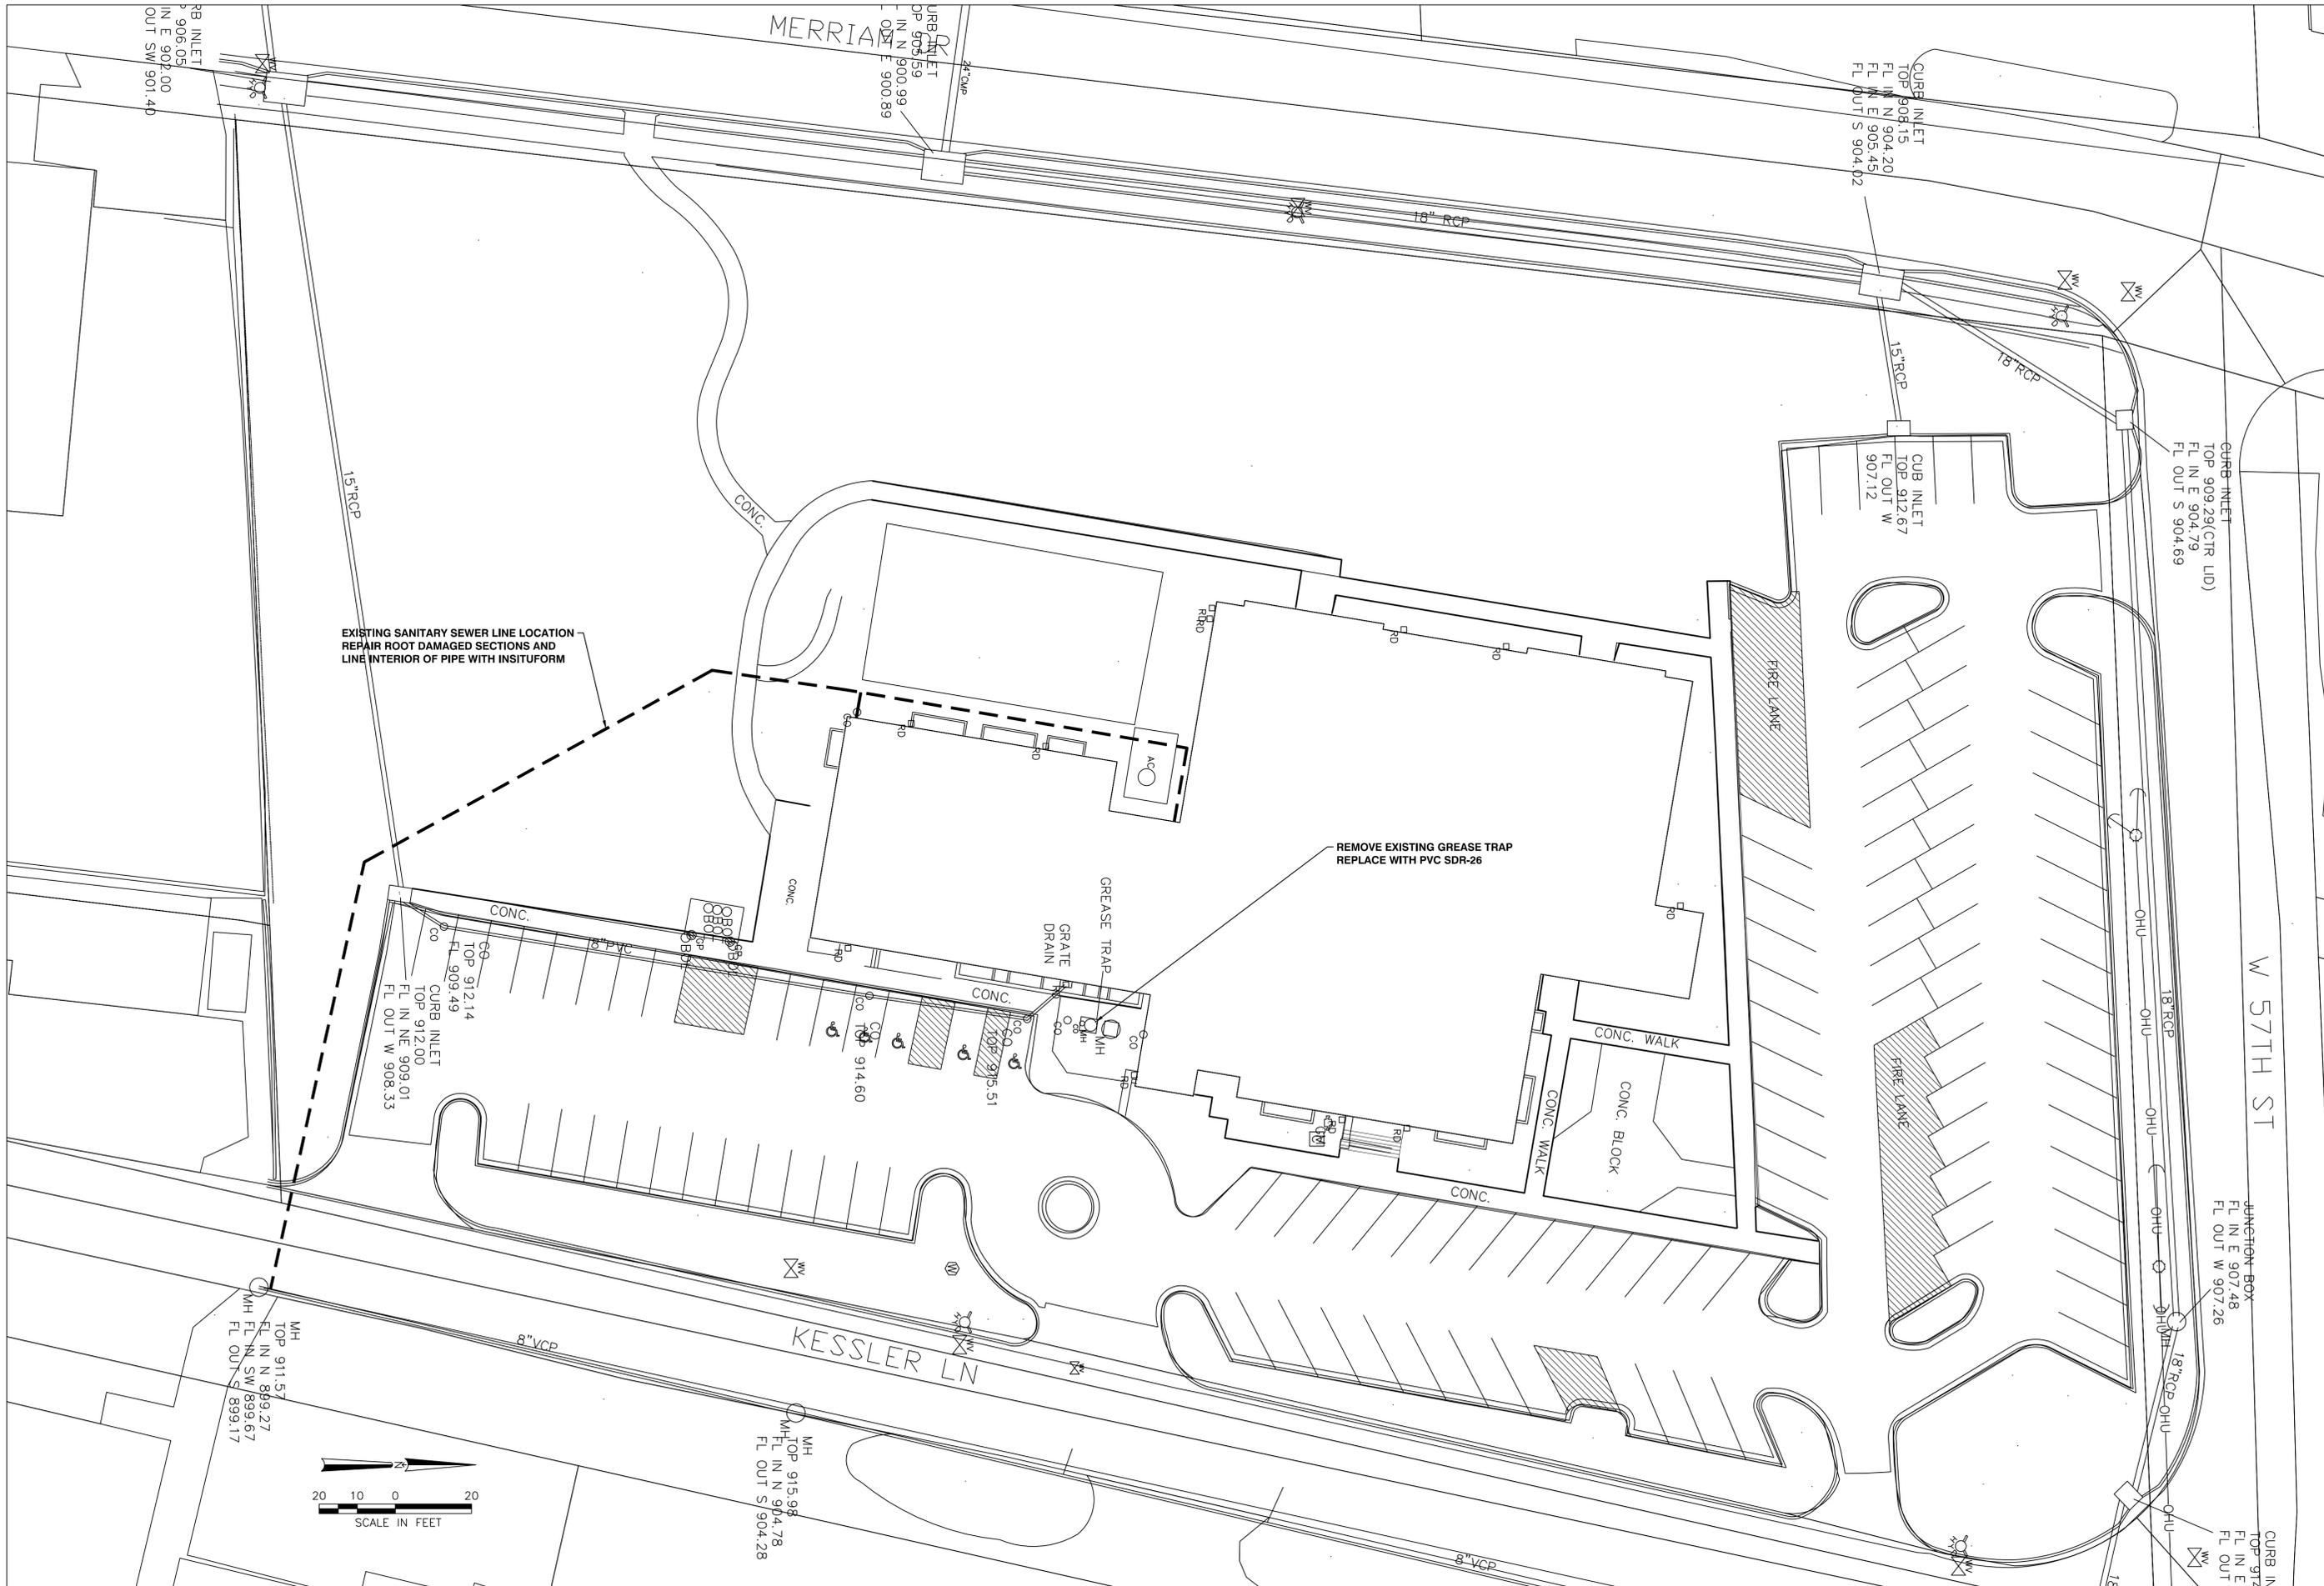
SEWER AS-BUILT/REPAIR
EXHIBIT 7

The video inspection indicated that a portion of the southern storm piping has an offset where the pipe has become slightly disconnected at a joint. This condition is typical of the installed pipe, reinforced concrete pipe (RCP). Due to the offset occurring within a grassy area of the property, the offset is not considered a critical issue. The area should be monitored for settlement which would indicate soil migration into the offset which may require further investigation and repair.

length. The video shows evidence of previous repairs, as well as existing root problems within the main line. It is recommended that any damaged sections (as depicted during the video inspection) be repaired followed by lining of the entire pipe with Insituform.

It is understood that due to the recommended interior plumbing modifications, the grease interceptor would no longer be necessary. This coupled with evidence from the video inspection that the grease interceptor was installed too low, resulting in the system holding water, is reason enough to remove and replace the interceptor with the new sewer pipe.

EXISTING SANITARY SEWER LINE LOCATION
REPAIR ROOT DAMAGED SECTIONS AND
LINE INTERIOR OF PIPE WITH INSITUFORM

REMOVE EXISTING GREASE TRAP
REPLACE WITH PVC SDR-26

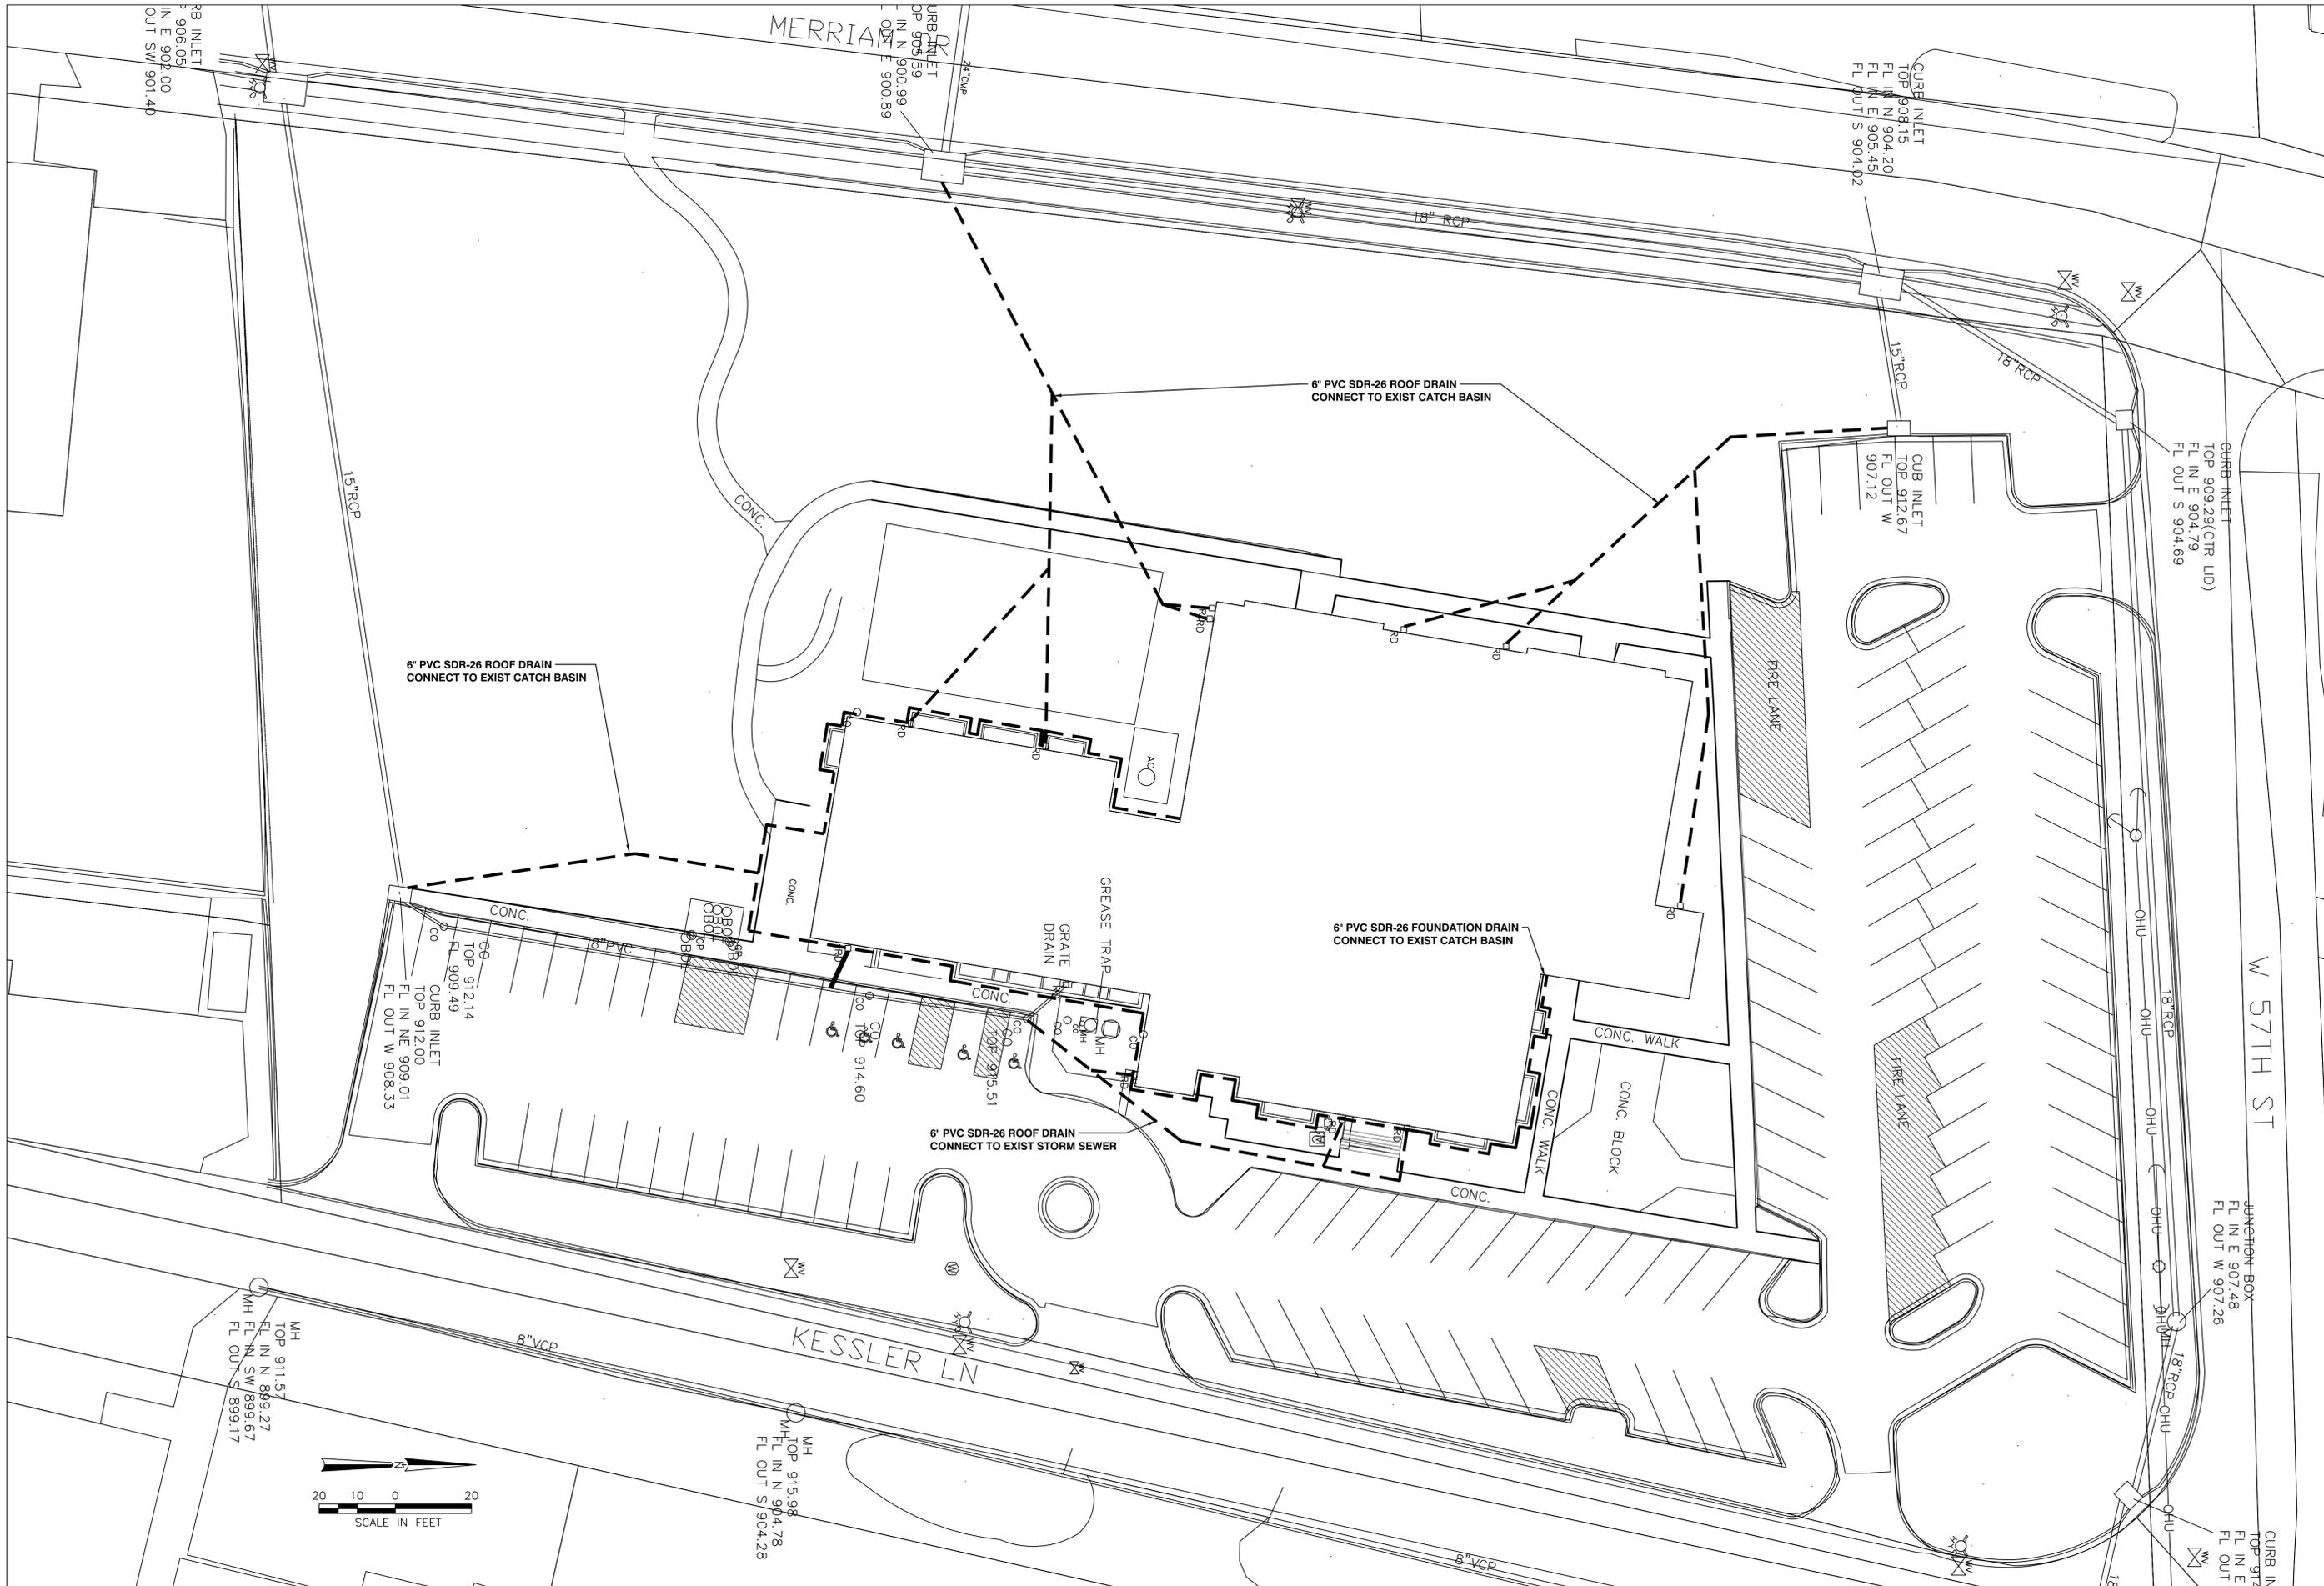
SITE DRAINAGE
 EXHIBIT 6

The termination of the downspouts are inconsistent, with most surface drainage directed across the existing ground surface or the concrete walkways. There are existing trench drains within the concrete walkways, located on the east side of the building, covered by metal plates which are not currently being utilized and are mostly filled with leaves. It is recommended that all downspouts be connected to a sub-surface drain and terminated at one of the existing storm drain catch basins to avoid water having any potential to enter into the foundation or to create patches of ice on the walkways during the winter months. A proposed roof drain plan is depicted on Exhibit 6.

Surface drainage away from the building is not currently being effectively achieved due to the build-up of landscaping material around the perimeter of the building. Over time, the landscaping has increased and created a condition where the ground has become level with the existing window wells or in many instances, above them. Additionally, the overgrowth and raised areas have created a level surface or even reverse grade toward the building, resulting in water not being properly directed away from the building. The deteriorated state of the window wells has contributed to this infiltration, as well. It is recommended to remove any built-up landscaping and provide positive grade away from the building.

Due to the community center's proximity to the flood zone and the utilization of multiple sump pumps, it is apparent that sub-surface water is a considerable issue on the site. In order to establish a more permanent solution, SKD recommends that foundation drainage be installed around the perimeter of the foundation as outlined on Exhibit 6.

1. Re-grade around entire building and install foundation French drains.
 - Install new continuous French drain around entire perimeter of the building and connect to existing storm water system.
